FIRST RECORD OF MAYFLY *POVILLA (LANGUIDIPES) TAPROBANES* HUBBARD FROM KARNATAKA

Mayflies are important as macroinvertebrates of aquatic ecosystems and are reliable bioindicators of water quality. Most mayfly nymphs feed by scraping algae from underwater rocks or by extracting food particles in the littoral and benthic zones of the water bodies. The mayfly *Povilla (Languidipes) taprobanes* originally described from Sri Lanka was observed in plastic lined ponds in coastal Karnataka. Not only, this is the first report of the species from Karnataka, but the unique case making behaviour of this species is also described for the first time. Additionally, the species was found damaging plastic tarpaulins of 750 gsm thickness used as lining for water storage in the tank by chewing. This chewing behaviour was responsible for damage of plastic sheets leading to water leakage. The possible loss caused and a need of alternate strategies to store water is discussed.

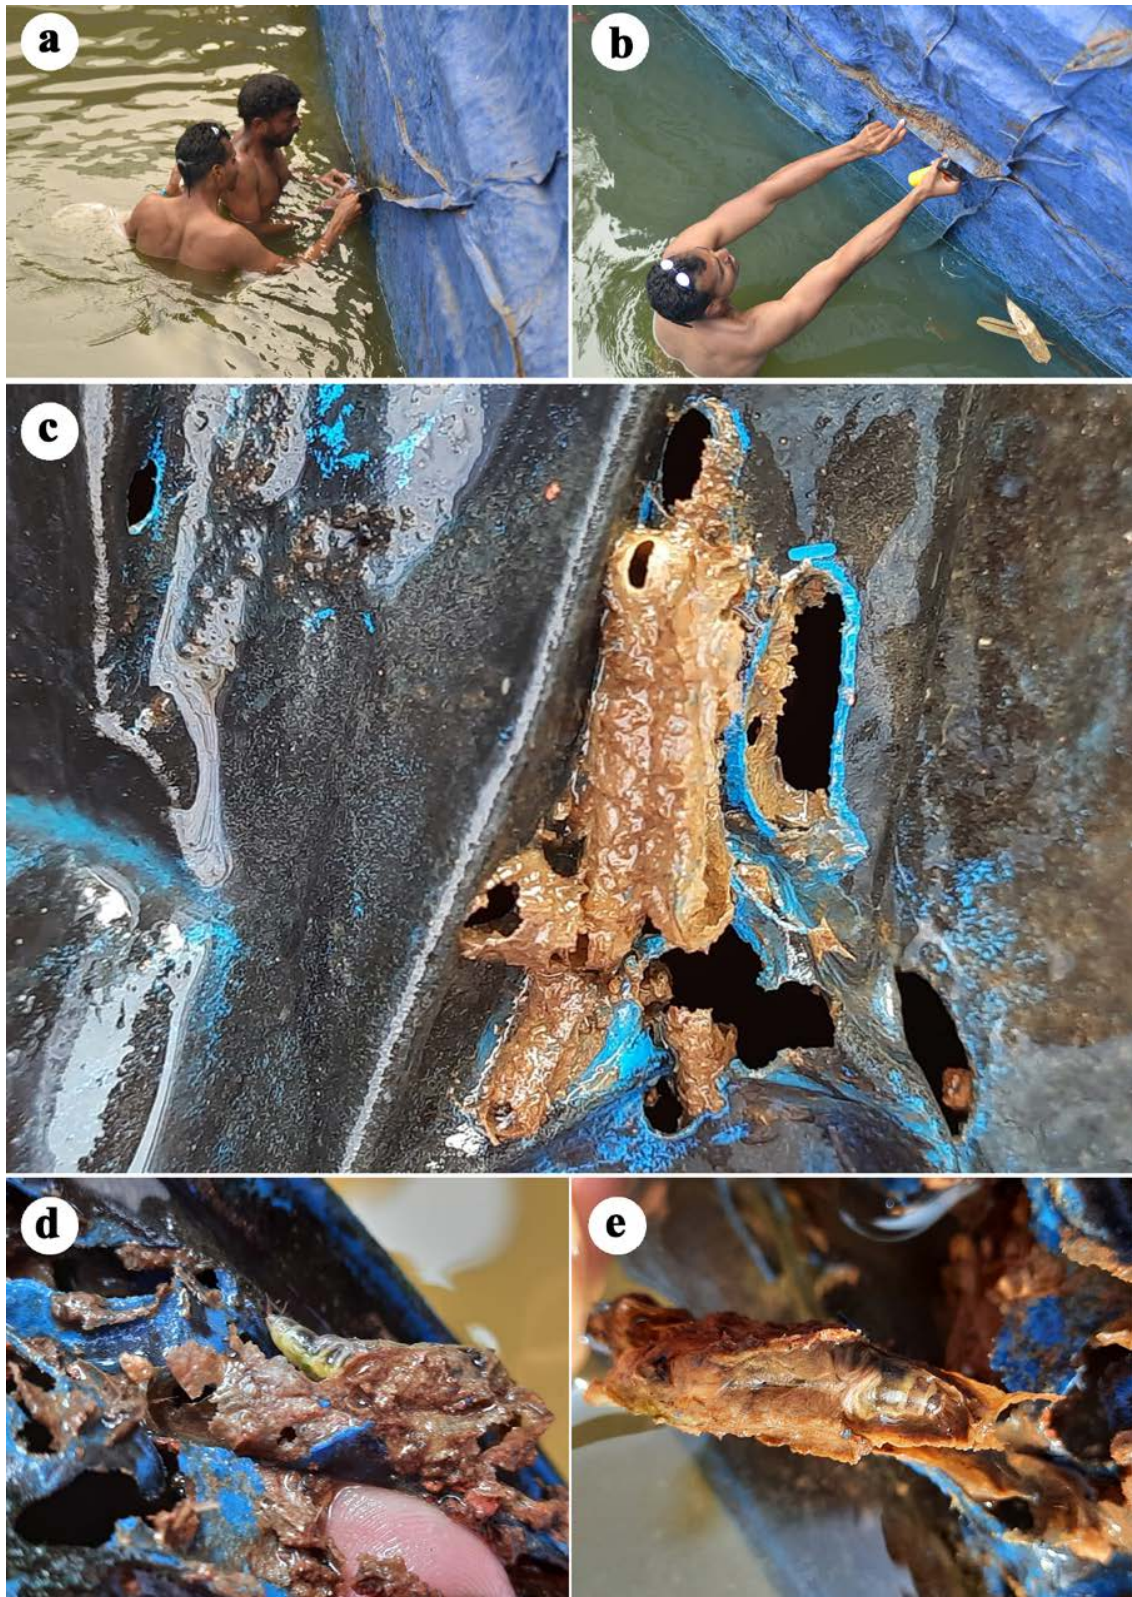
Fig. 1. Sample collection; a-c) Larval case with larvae; c-e) Damaged folds of tarpaulin sheet

The plastic folding where the lining was damaged with punctures had small tunnels or burrows and earthen cases made of fine silt with very small fragments of the plastic lining (Fig. 1 a-c). These tunnels and cases were found to harbour larvae of mayflies (Fig. 1 d-e) and often the disturbance forced out the larvae from their resting places enabling collection. Invariably the plastic lining of the pond was damaged wherever there was an aggregation of the larvae. Samples of free-living larvae were also taken from the pond using an aquatic net. The larvae were collected in 90% ethyl alcohol from the second pond and identified to species level based on the keys provided by Hubbard (1984) and Rathinakumar et al. (2019) and also confirmed by a taxonomist specialising in Ephemeroptera (Dr. Boonsatien Boonsoong, Bangkok, Thailand). Further, efforts were also made to collect information from Mr Sebastian, Proprietor Shakthi Tarpaulin in Kerala who supply tarpaulin sheet for farmers and also people who previously encountered holes in tarpaulins installed in rain water harvesting units. The information obtained is also represented to indicate the importance of correct diagnosis.

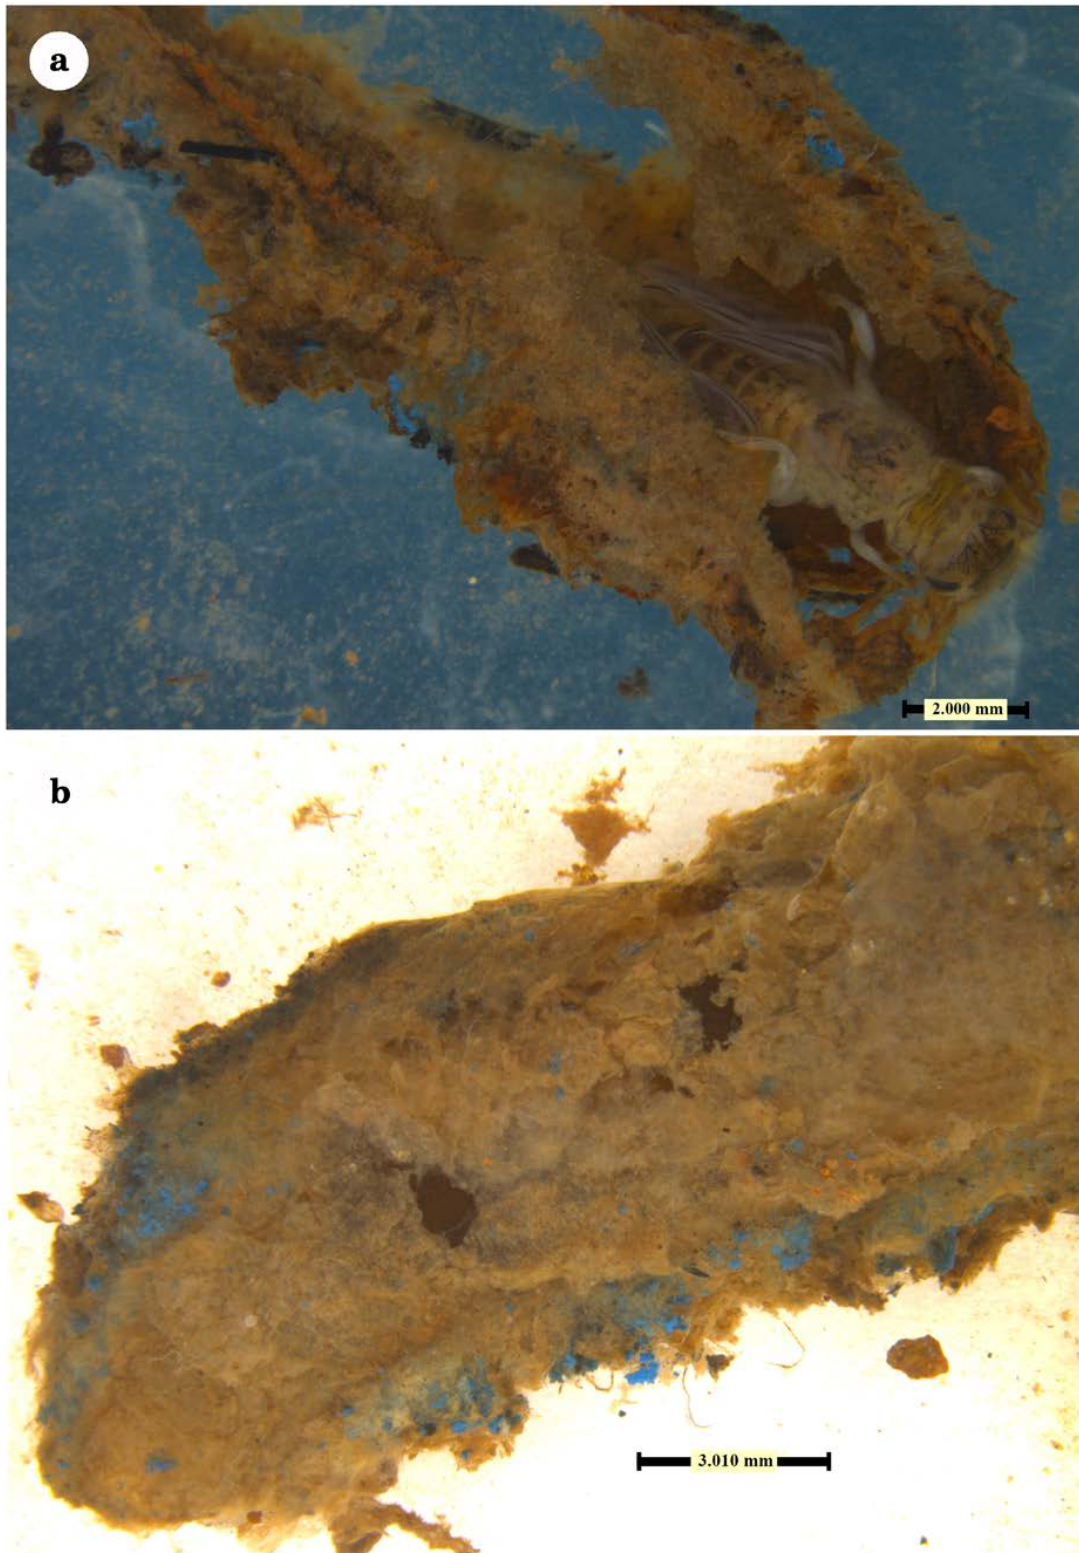
Fig. 4. *P. (L.) taprobanes* larvae; a. Larval case with naiad; b. Larval case with plastic particles

Povilla (Languidipes) taprobanes was originally described from Sri Lanka (Hubbard, 1984) and later observed from Tamil Nadu (Rathinakumar et al., 2019). Herein its occurrence from Karnataka is reported for the first time. The larvae when disturbed were observed to come out of the cases made of mostly silt and sand with tiny fragments of plastic (Fig. 4 a,b). The holes were found with cases on the plastic sheets folding, strongly implicating the larvae in the damage to the lining. It is presumed that the damage could have been caused due to larvae burrowing in the fold, and chewing or clawing through the plastic lining to build earthen cases. It is also possible that the larvae used the folds as an 'enemy free space' to hide from their natural predators in the aquatic habitat (Gallitelli et al., 2021). The loss appears to be though less, considering that large number of farmers following this system of water conservation, where plastic sheets are laid on the dug pits of different sizes and water is stored the damage can be critical. Hence, there is a need of ascertaining case making and chewing behaviour. At this juncture, it is not clear, whether there is any ingestion of plastic by the mayflies. Recently, the ingestion of microplastics by Ephemeridae (Baetidae, Heptageniidae) was proved in riverine habitats (Windsor et al., 2019).
